**Re: Request for Access to Information Under Part II
of the Access to Information and Protection Privacy Act
154 New Cove Road**

FINAL
Hazardous Building
Materials
Assessment

154 New Cove Road, St.
John's, Newfoundland and
Labrador

Issued on: **November 24, 2015**
Pinchin file: **02-02-01600**
Issuing Office: **27 Austin Street, 2nd Floor, St.
John's, NL A1B 4C3**

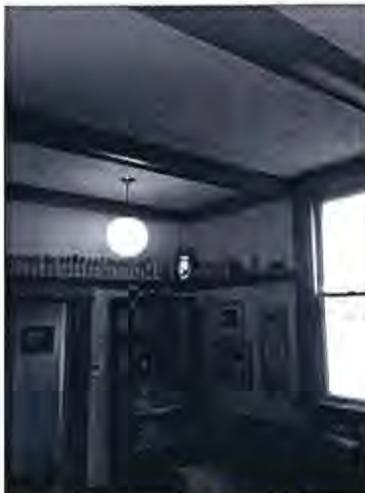
Texture finish is present on plaster ceilings in the Family Room (sample 02-02-01600-S008). No asbestos was detected in the texture coat samples.

Texture coat observed in Family Room.

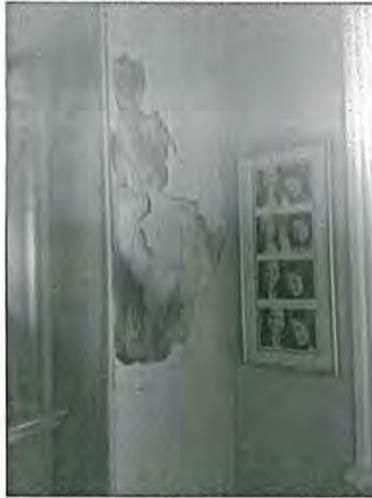
Plaster is present on walls and ceilings in the building. A total of nine samples of plaster (samples 02-02-01600-S001, 02-02-01600-S007, 02-02-01600-S011, 02-02-01600-S012, 02-02-01600-S013, 02-02-01600-S014, 02-02-01600-S018, 02-02-01600-S019 and 02-02-01600-S021) were collected and found that the plaster contains chrysotile asbestos in the base coat. Plaster is non-friable while in place, but generates friable dust upon removal. The wall and ceiling finishes in the building are plaster and approximately three hundred and fifty square feet (350 ft²) of this material was observed in poor condition.

Plaster finish in Bedroom 1 in poor condition.

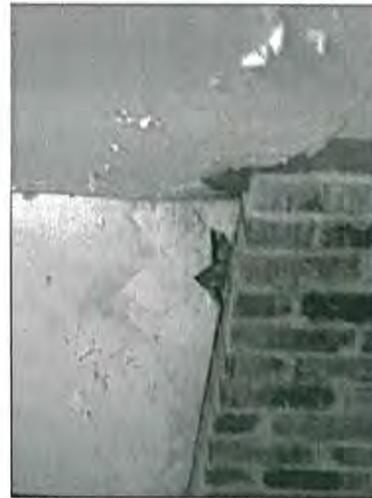
Plaster finish in the 3rd floor Storage Room observed in poor condition.

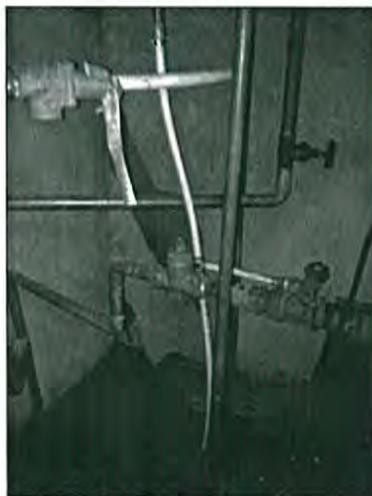
Transite board, containing chrysotile asbestos, is present on the walls surrounding the furnace system and stored in the Furnace Room (sample 02-02-01600-S003). This material is non-friable and eighty square feet (80 ft²) was observed in good condition and twenty square feet (20 ft²) in poor condition.

Transite board behind furnace system.

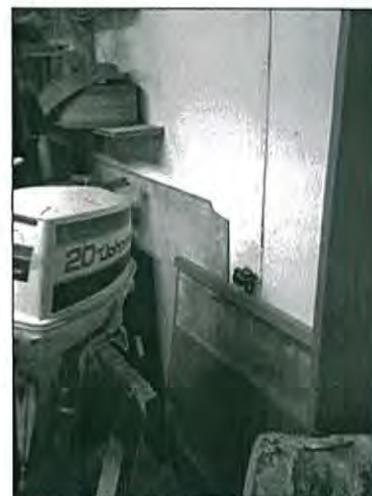
Transite board in storage in Furnace Room.

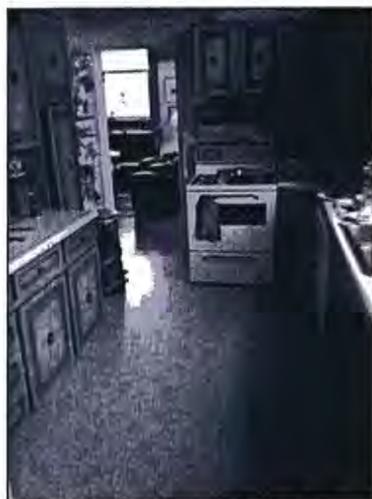
The vinyl sheet flooring is non-friable but can become friable upon removal. All vinyl sheet flooring was observed to be in good condition.

Vinyl sheet flooring in the Kitchen.

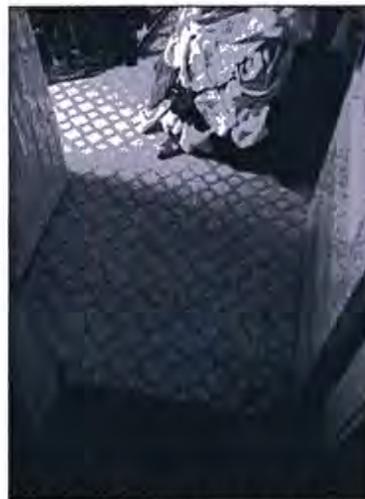
Vinyl sheet flooring in the Laundry Room.

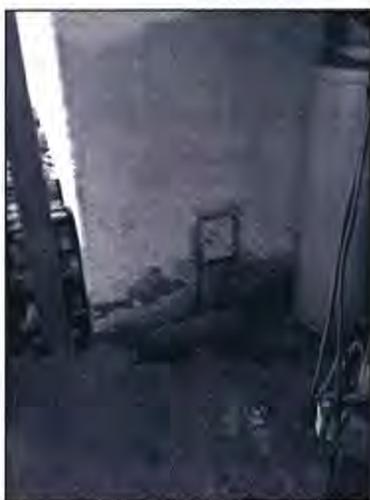
The tan floor, yellow wall, blue wall, white wall, grey wall, and green siding paints identify as a potential exposure risk to workers, with lead levels over 600 mg/kg or 0.06%. In addition, the tan concrete floor and grey plaster wall paints exceed the criteria for disposal with lead levels exceeding 5000 mg/kg or 0.5%, and as such should be subjected to leachate analysis to determine if additional disposal measures are necessary. There are multiple areas of with a total of approximately four-hundred (400) square feet flaking, peeling, and delaminating paints throughout the building.

Tan concrete floor paint in the Furnace Room.

Lead-painted items may be a hazardous waste. Test lead-painted materials that exceed the provincial screening criteria for leachable lead prior to disposal to determine if they need to be treated as hazardous waste.

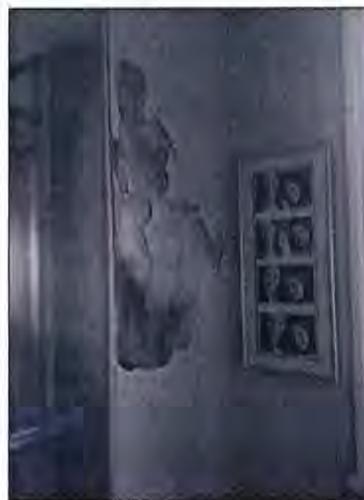
Grey wall paint in Bedroom 1.

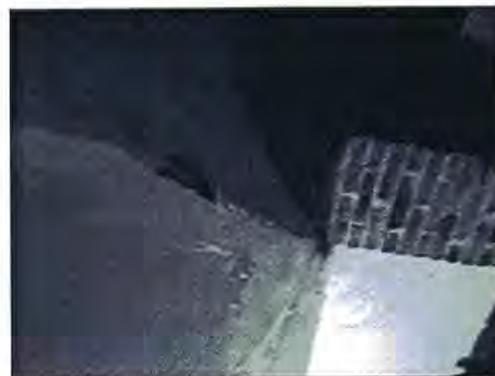
Mould was not observed, however multiple areas of visible water staining were observed on plaster finishes in the basement stairwell, back porch, bedroom 1, 3rd floor storage room and tower room.

Water damaged finishes in the 3rd floor storage room.
