Re: Request for Access to Information under Part II of the Access to Information and Protection Privacy Act (the ATIPP Act, 2015)

I request the following documents that pertain to the selection of the site, design, construction and operation of the Paul Reynolds Centre:

Table 1 Results of Laboratory Analysis of Petroleum Hydrocarbons in Soil
Soil and Water Sampling, Concrete Septic Tank
Wedgewood Park Aquatic Centre Site, St. John's, NL
Stantec Project No. 121617902

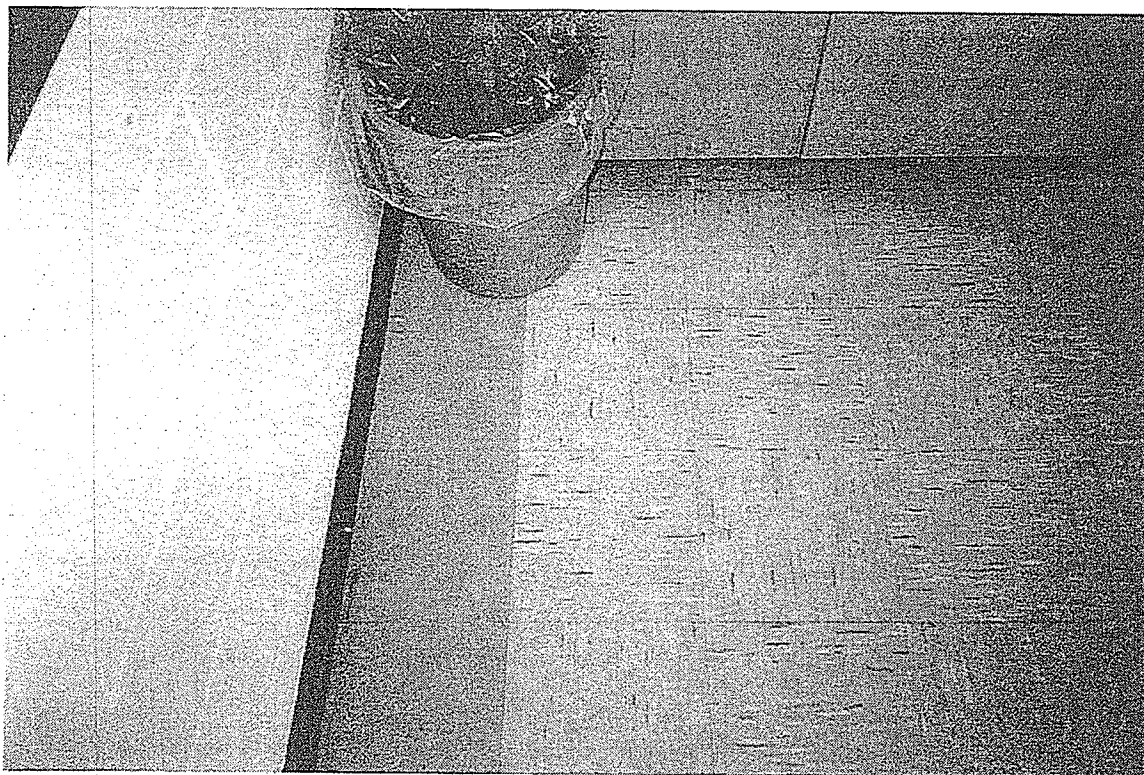
Vinyl floor tiles were observed/sampled throughout the building during the assessment. The beige floor tiles observed were sampled and found to contain up to 10 percent chrysotile asbestos (see sample 11).

FLOOR TILE, ROOM 116.

All asbestos containing material in poor condition should be repair or removed as soon as possible.

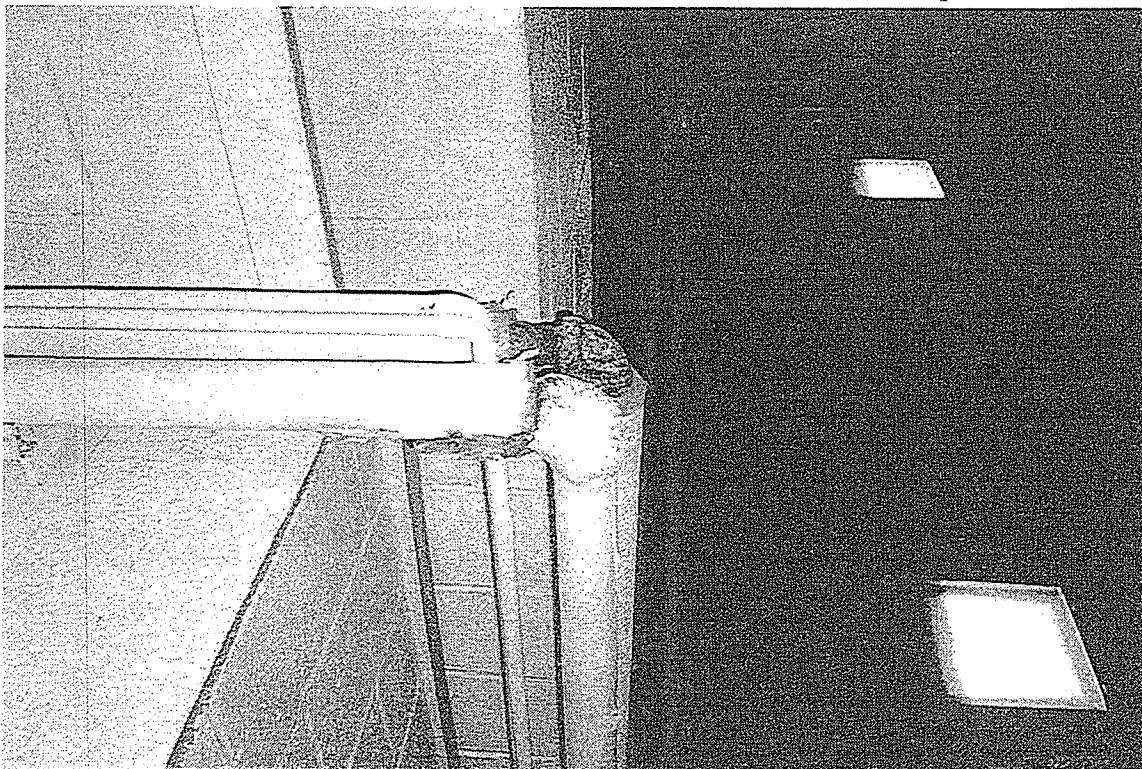
Most original mechanical pipe insulation fittings contains asbestos throughout the building. Based on our sample analysis, fittings were found to contain up to 50 percent chrysotile by volume. (see samples 01, 04 and 05). All pipe insulation was found in good to poor condition. The breeching from the boiler in the boiler room

PIPE FITTINGS, ROOM 100.

Use Type I/ Type II repair methods to repair damaged mechanical piping insulation located in the basement and garage area were applicable.
